**DAM SAFETY INSPECTION  
REPORT**

**GORGAS STEAM PLANT  
WALKER COUNTY,  
ALABAMA**

**PROJECT NO. 09-4157  
JULY 2009**

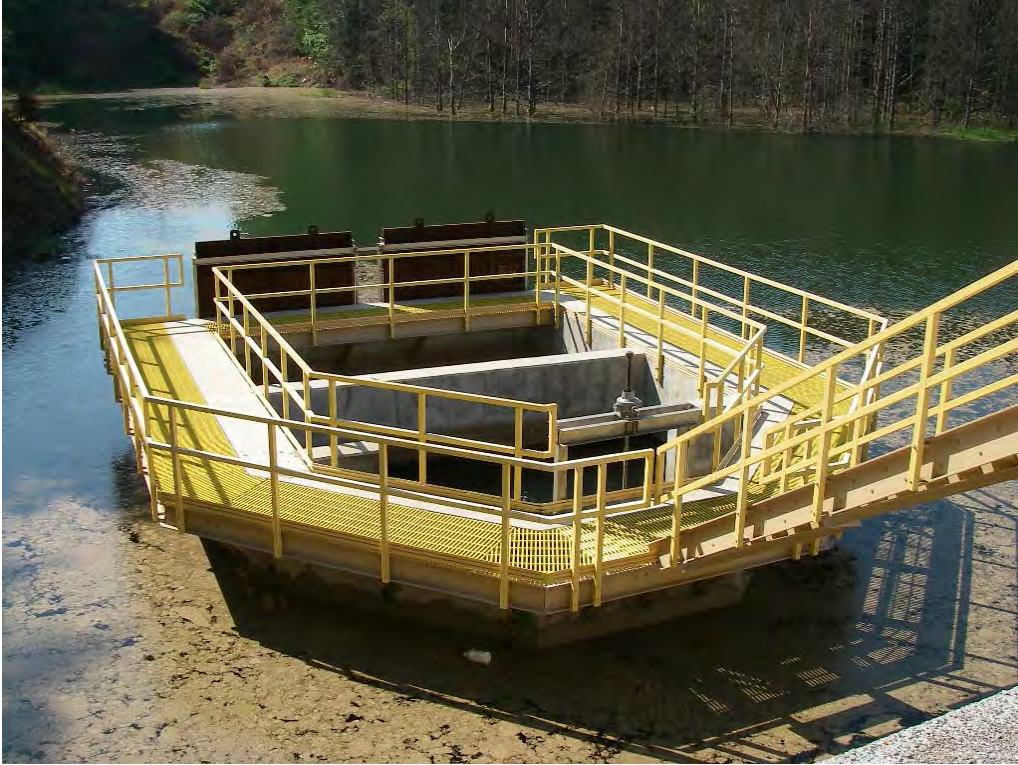
**PHOTO 1: RATTLESNAKE DAM WEIR FLOW INTAKE STRUCTURE**

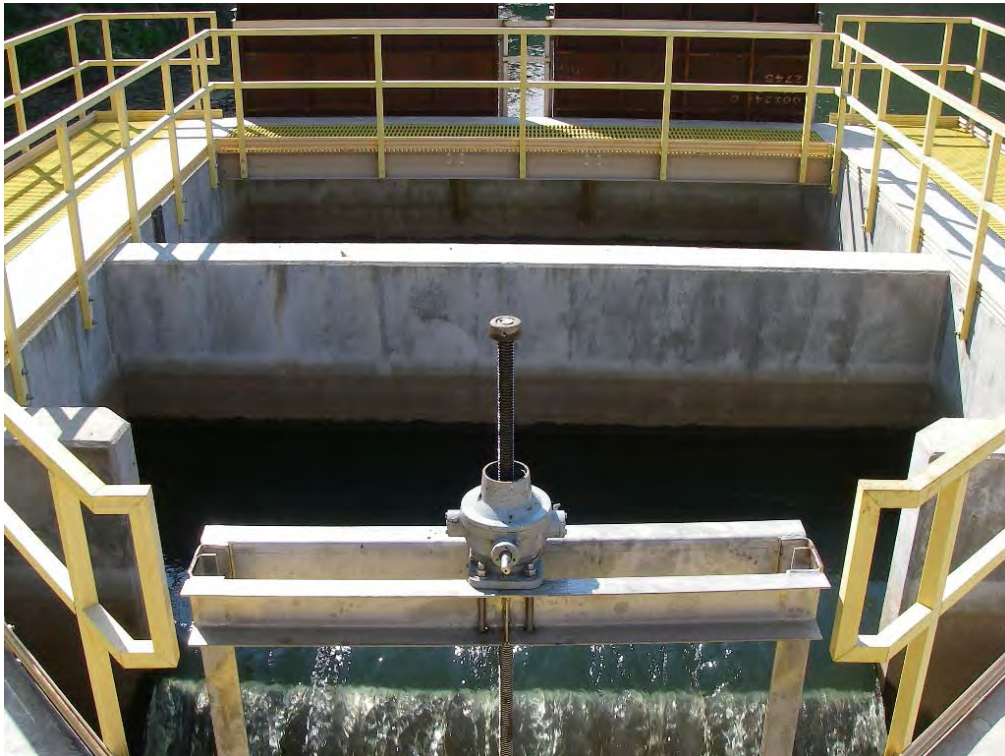
The weir intake structure is a new reinforced concrete structure in excellent condition. This structure outlets into a 48-inch diameter corrugated metal pipe that carries decant water down the hill to the NPDES permitted release point. The release point is under water, therefore observation of the water at the point of discharge was not visible. Water at the point of entry was clear water. (See Photo 2).

**PHOTO 2: CLOSEUP OF WEIR INTAKE**

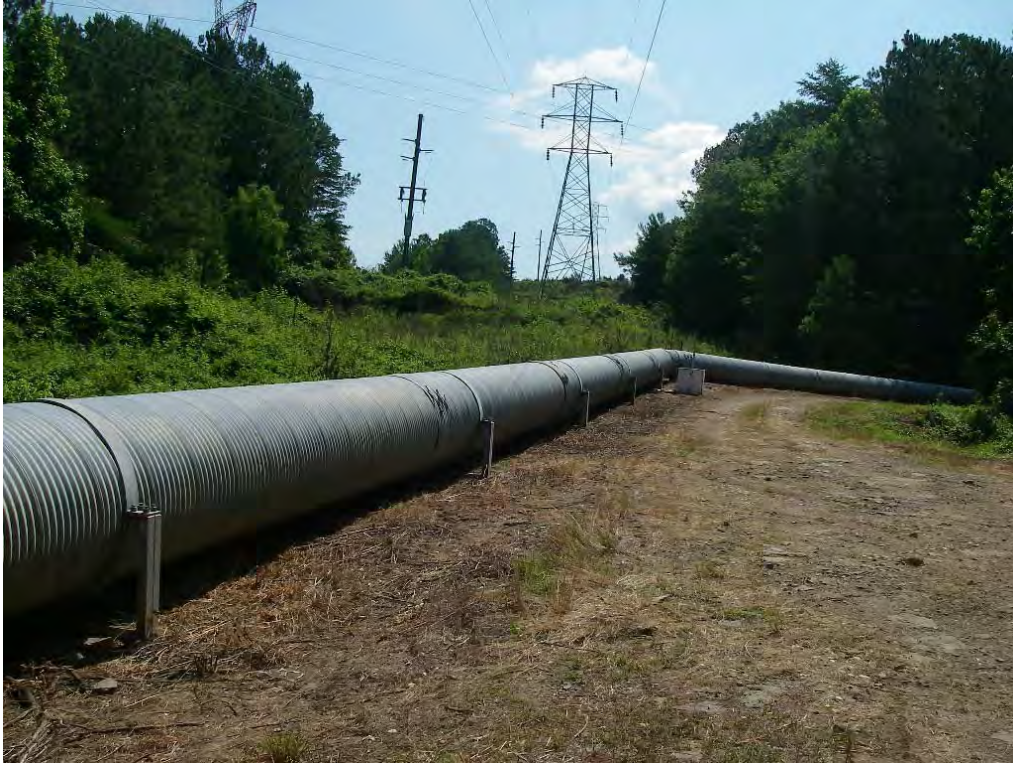
**PHOTO 27: DISCHARGE LINE FROM RATTLESNAKE DAM TO BLACK  
WARRIOR RIVER**

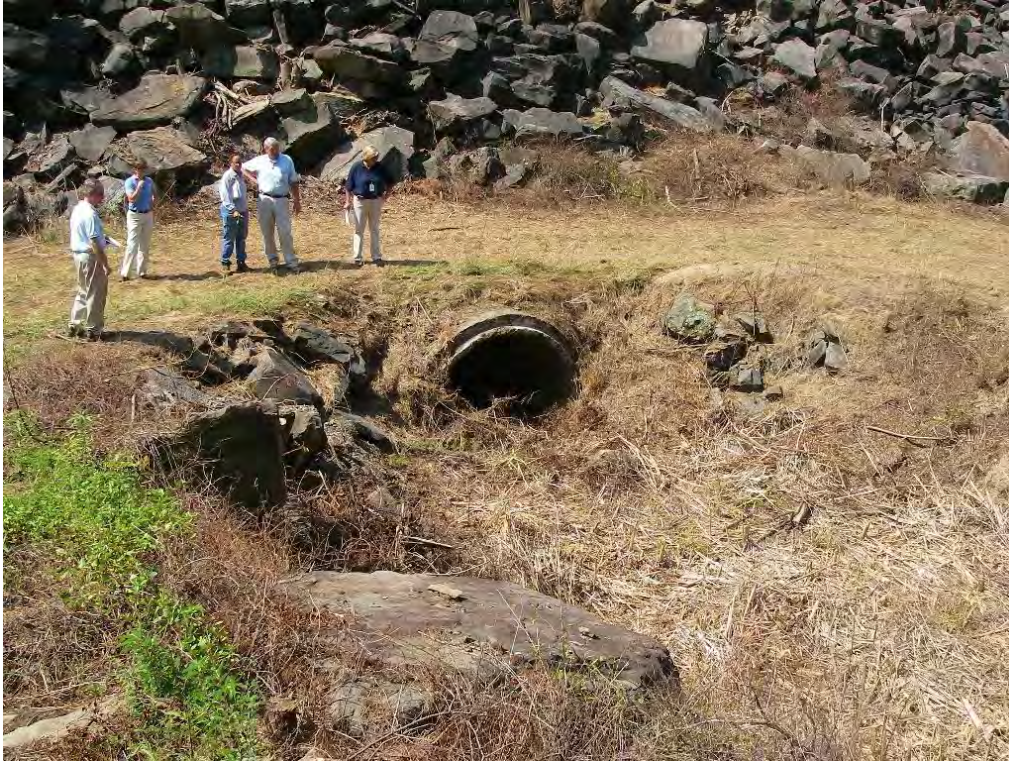
**PHOTO 15: ORIGINAL BYPASS CHANNEL & CULVERT (ABANDONED,  
LOOKING S)**

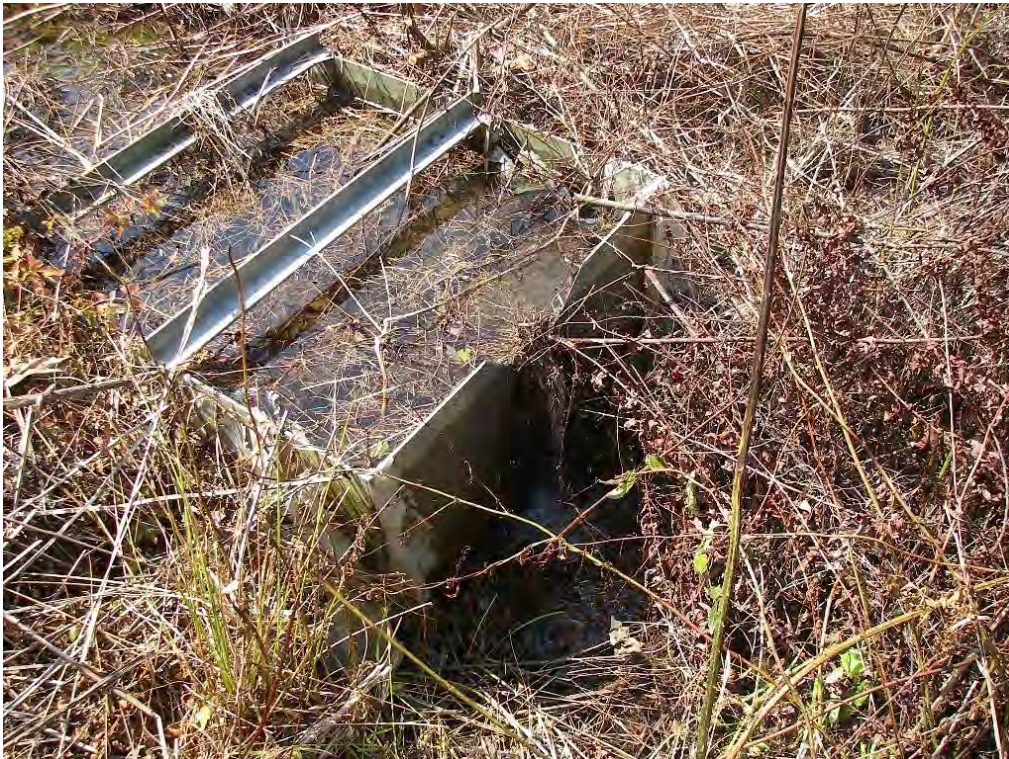
**PHOTO 18: OVERGROWN SEEPAGE MEASUREMENT WEIR**

In conjunction with Recommendation No. 1, the existing weir box at the toe of the downstream slope of Rattlesnake Dam should be cleaned out and repositioned, or replaced with a larger weir if necessary, to collect the seepage flow along the downstream toe observed at the time of inspection. As much of the seepage currently visible should be collected as possible and the small ditch creating the current flow path should be kept as clear as possible to facilitate observations of changes in volume, turbidity, or location of new seeps. Such information, along with the flow measured at the box should be recorded as a part of Recommendation No. 1, so that seepage trends can be established and reviewed easily. In the event of increased seepage flows, the installation of additional instrumentation and a more involved monitoring program may be warranted.

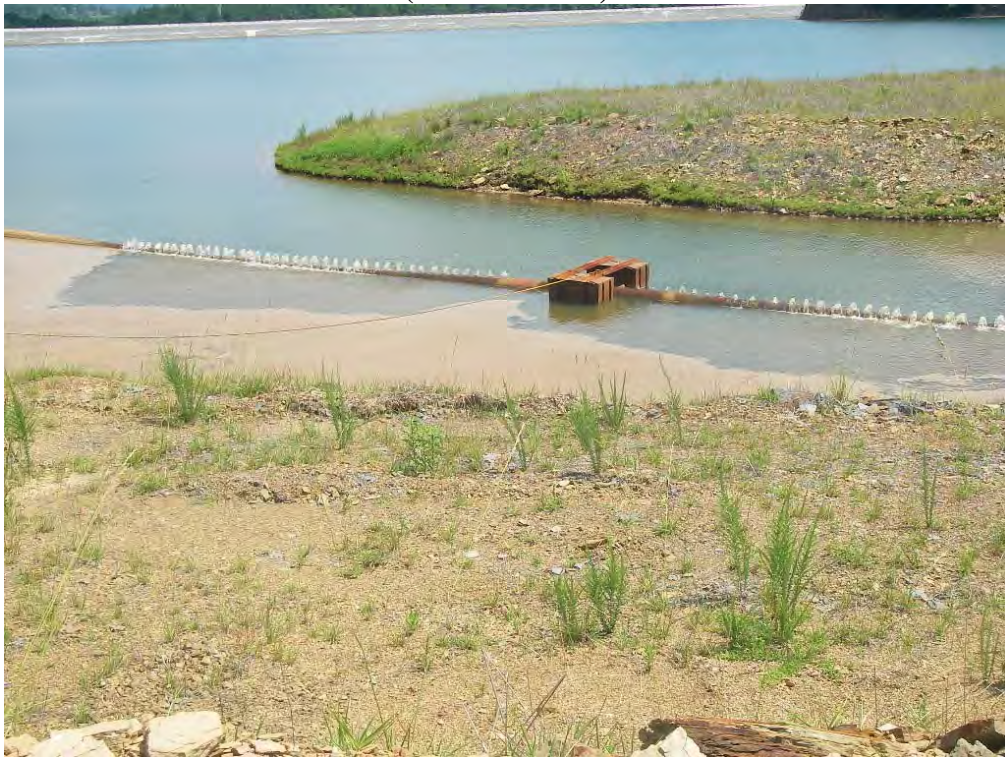
**PHOTO 32: BUBBLER AERATION LINE AT INTERMEDIATE DIKE  
(LOOKING E)**

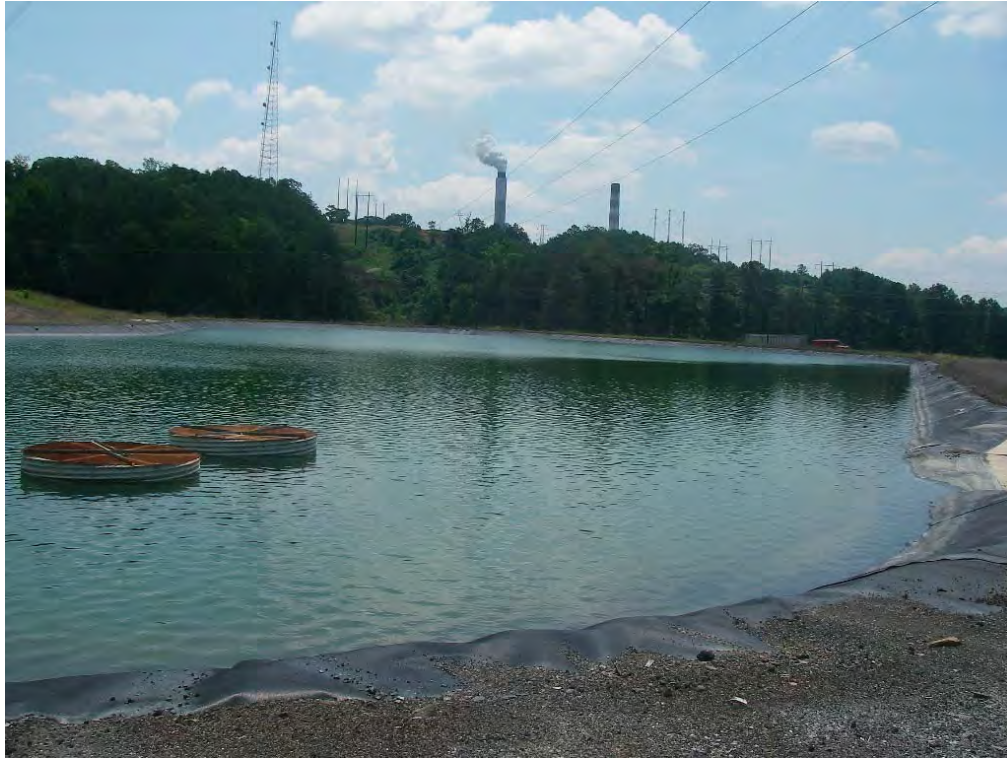
**PHOTO 35: DECANT PIPES IN SEDIMENT BASIN**

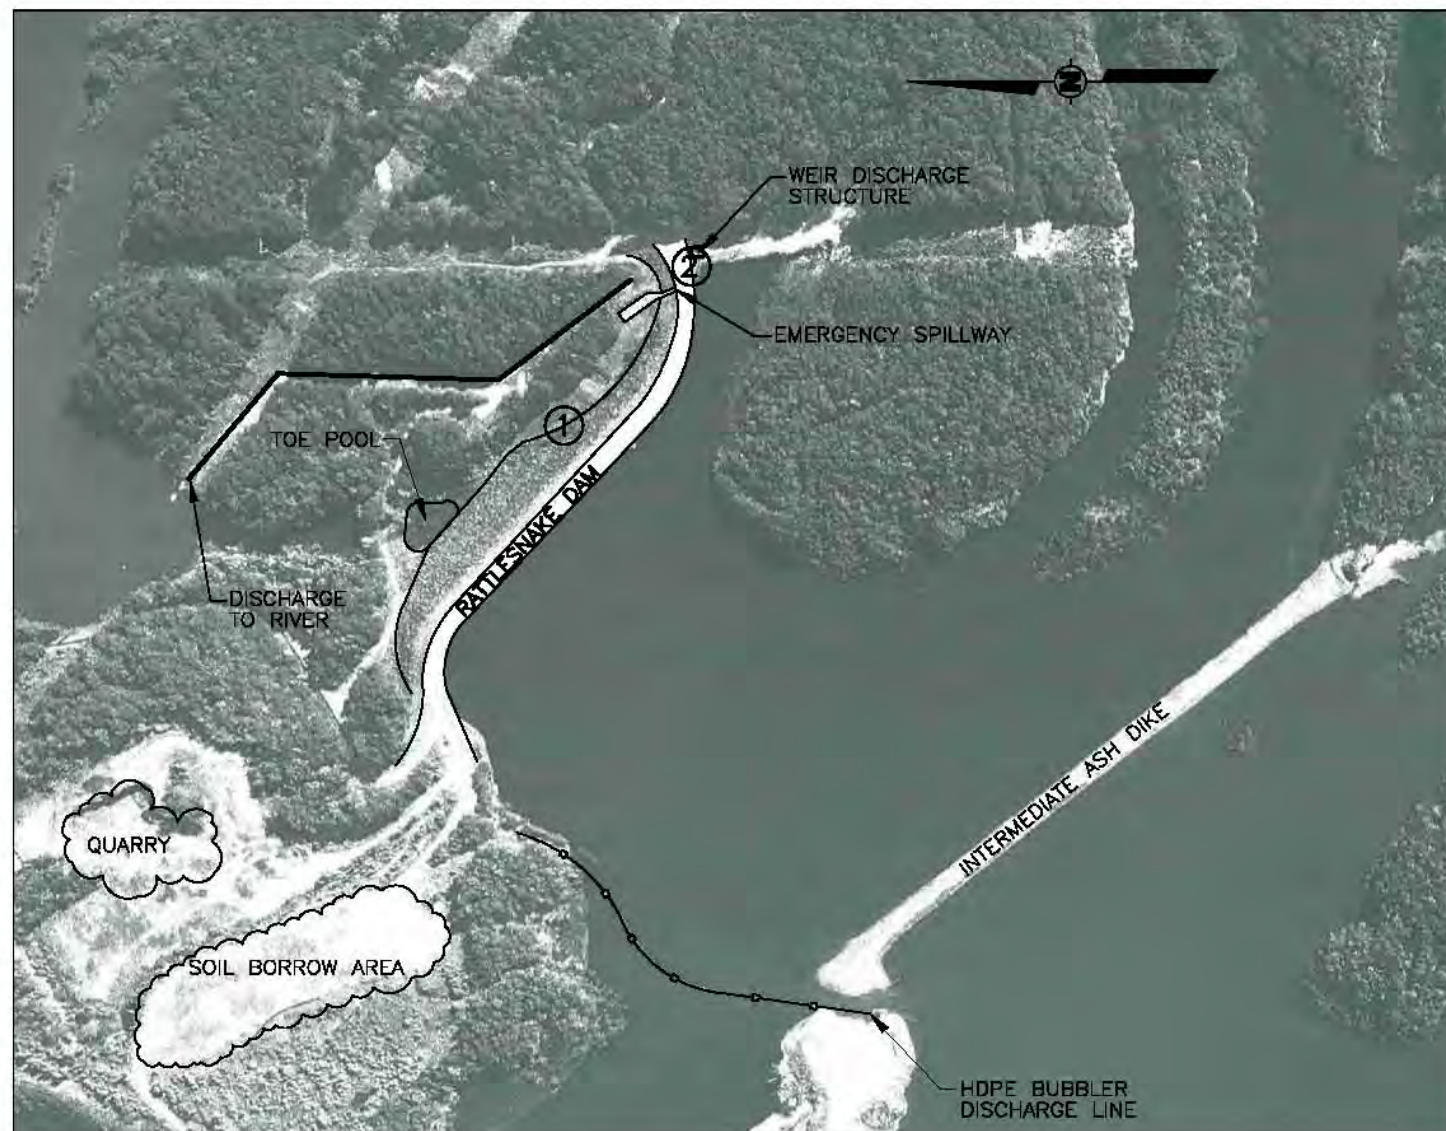
**FIGURE 2**  
 RATTLESNAKE HOLLOW  
 ASH POND AND FEATURES  
 GORGAS PLANT  
 DAM SAFETY INSPECTION  
 PREPARED FOR

- ① APPROXIMATE LOCATION OF SEEPAGE FROM TOE.
- ② CRACKING IN RCC FACING BLOCK NOTED HERE.
